**PRELIMINARY REPORT NO. 1**  
**DEMOLITION/SALVAGE ANALYSIS**  
**OF**  
**OFFSHORE PLATFORMS**  
**STAGE I AND II**

This preliminary report presents the equipment inventory and inspection results.

**CONTRACT N62477-82-C-0393**

**May 1983**

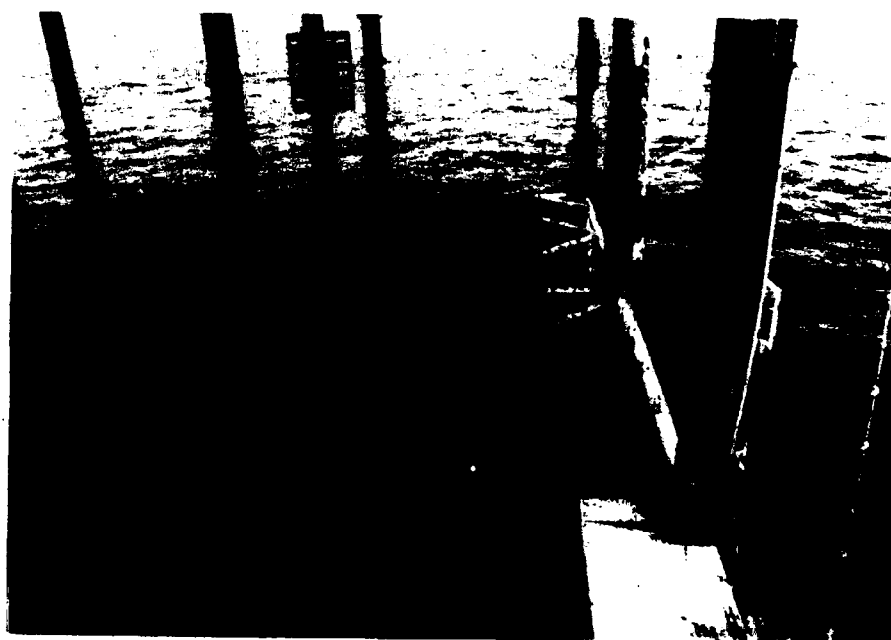
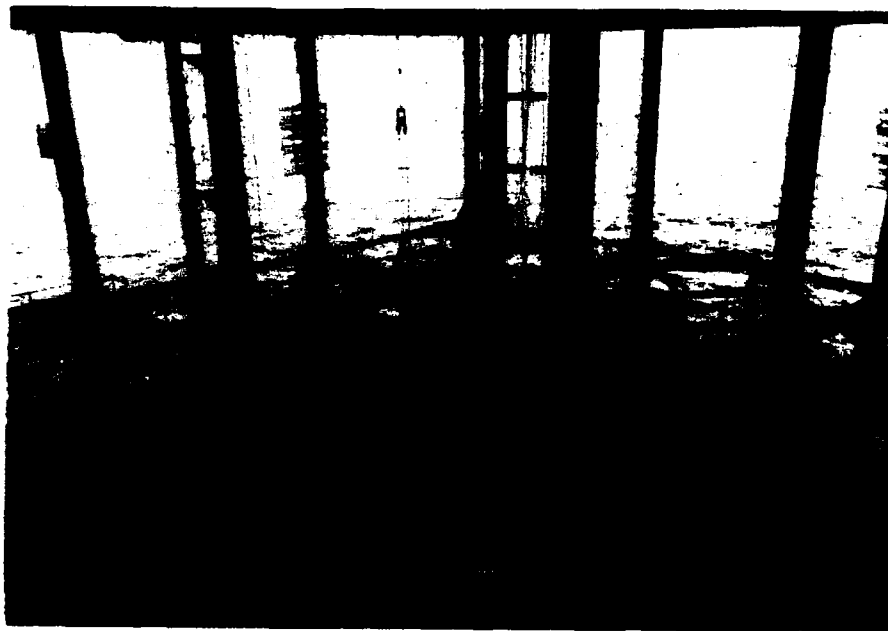
At the El. (+) 10 ft level of the jacket general corrosion is apparent on all steel that is not covered by monel. Where the angle iron supporting the anode cables are bolted to the horizontal jacket members, corrosion is visible. The monel covering appears in good condition except where attempts have been made to weld to it. At these locations, rusting is noticeable. In several areas, grating is missing, washed off by wave action.

Figures 2.2.17 through 2.2.19 show the overall condition of the top of jacket framing on Stage I.

The boat landing and barge bumpers are in very poor shape, with heavy corrosion and deep pitting all over. Some of the timbers have fallen off the barge bumpers. The shims between the jacket

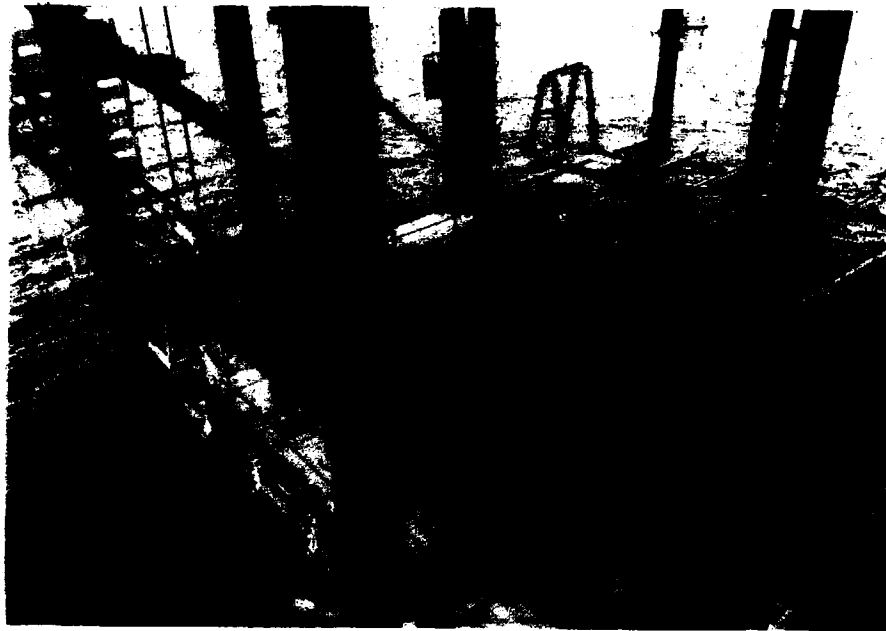
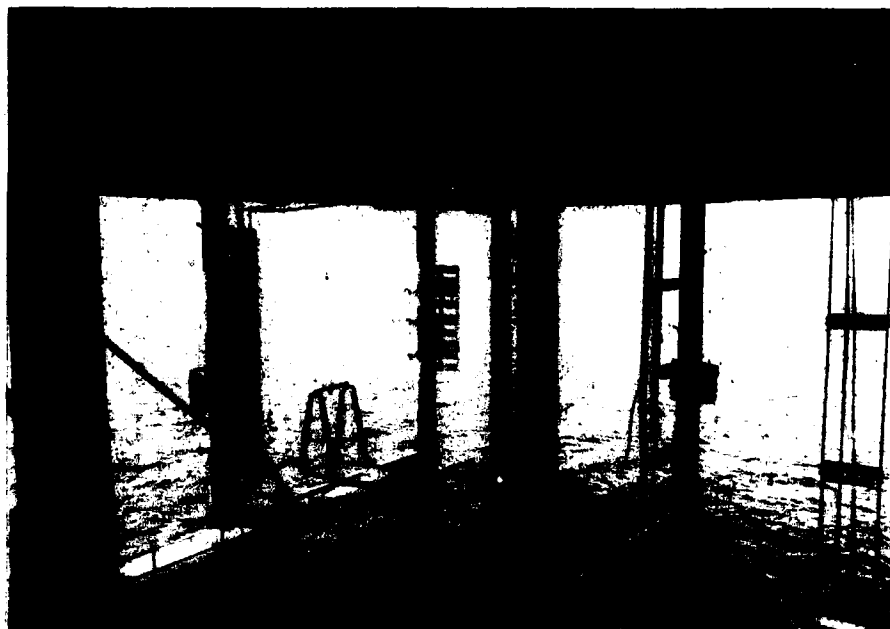
The condition of the top of jacket at El. (+) 12 foot level is poor. All steel not covered by monel shows rusting and pitting. The monel appears in good condition except where attempts have been made to weld to it. At these spots, rusting is visible.

Where the angle iron supporting the anode cables are bolted to the horizontal jacket members, corrosion is visible. In several areas, grating is missing, apparently washed off by wave action.

Figures 2.3.8 through 2.3.11 show the overall condition of the top of jacket framing on Stage II.

The boat landing and barge bumpers are heavily corroded with some timbers missing. Pits in excess of 1/4 inch exist on the jacket legs where corrosion products are visible.
